TP 185E
Issue 3/2005

AVIATION SAFETY LETTER

Aircraft Icing for General Aviation... And Others

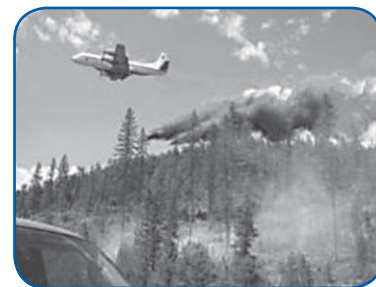
The Electra seen delivering retardant to target fire moments prior to the accident.
